FIRST INTERIM REPORT

**ELEVATED TEMPERATURE STRESS
CORROSION OF HIGH STRENGTH
SHEET MATERIALS IN THE PRESENCE
OF STRESS CONCENTRATORS**

Contract NASr-50

**NATIONAL AERONAUTICS AND SPACE ADMINISTRATION
Washington 25, D. C.**

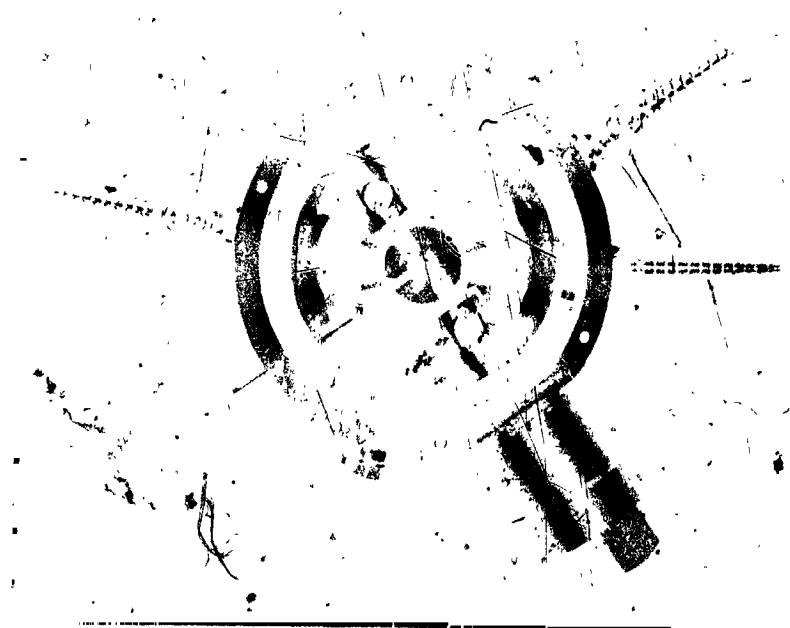
Fig. 32 a - SCHEMATIC DRAWING OF TENSILE HOT STAGE - Side View
 b - PHOTOGRAPH OF INTERIOR OF HOT STAGE - Top View
